NASA CR-135113
TRW ER-7821F

**PMR POLYIMIDE/GRAFITE FIBER
COMPOSITE FAN BLADES**

**P. J. CAVANO
W. E. WINTERS**

1. Report No. NASA CR-135113	2. Government Accession No.	3. Recipient's Catalog No.	
4. Title and Subtitle PMR POLYIMIDE/GRAFITE FIBER COMPOSITE FAN BLADES		5. Report Date December 15, 1976	6. Performing Organization Code

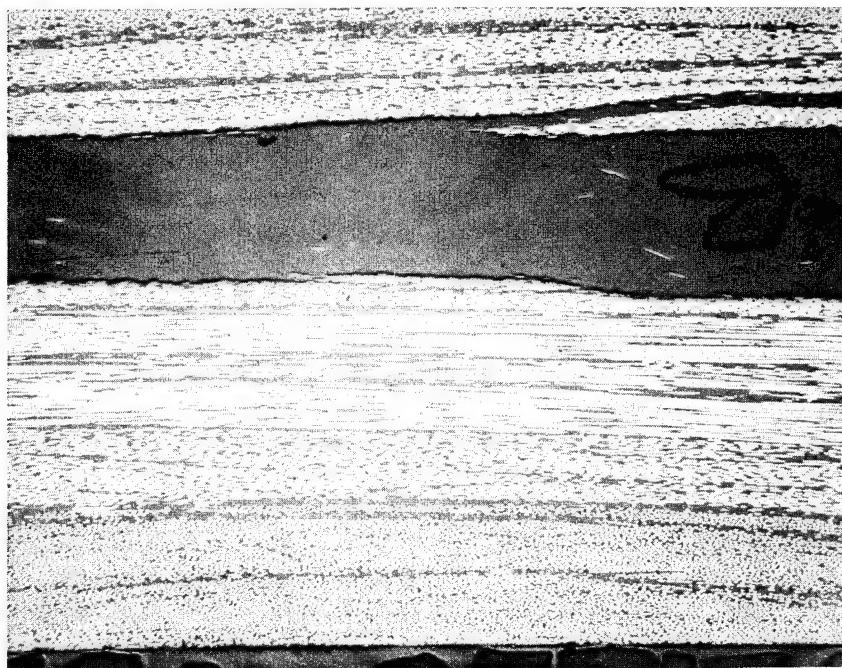
Figure 4. Magnified Photograph of Shear Specimen Showing Stress Crack Location in Construction IV.

An examination of all of the specimens before test revealed that many of the specimens from constructions IV and V (shown in table VIII) exhibited small laminar cracks originating at the corners of the rectangular specimens. The laminar cracks seemed to be associated with the interface of the core/shell constructions. None of the specimens from construction I, II or III exhibited any cracking. Since the same machining practices were observed with all specimens and the as-molded panels were free of stress cracks, as determined by X-ray, it was deduced that the machining operation altered the residual stress patterns in the panels which lead to the cracking.

The 3.8 cm (1.5 inch) long short beam shear specimens displayed the most cracks, although they could be observed in lesser numbers in the tensile and flexure specimens. The majority of these cracks were 3.2 to 6.4 mm (1/8 to 1/4 inch) long. A typical example can be seen in figure 4 showing a 7X magnification of one end of a short beam shear specimen from construction IV (table VIII). After test a number of specimens were examined to determine the exact location of the crack. This was done by a microscopic examination of polished sections and prying open the precracked specimens. Figures 5 and 6 are 40X photographs of specimens from constructions IV and V. In each case, the outside laminate ply can be seen at the bottom of the photograph. As can be seen, the cracks were intralaminar in nature, i.e., the failure occurred, not between two plies, but in the center of a 0.25 mm (10 mil) ply, and in both cases in an HM-S ply. The failure was observed within the fifth ply (-30°) of construction number IV and in the fourth ply (-10°) in construction number V.

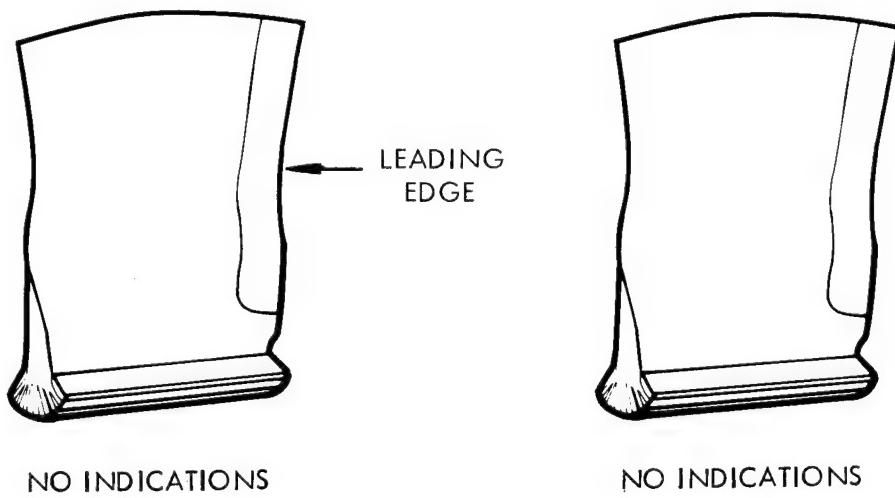
FIG. 26 S/N T-14

NO INDICATIONS

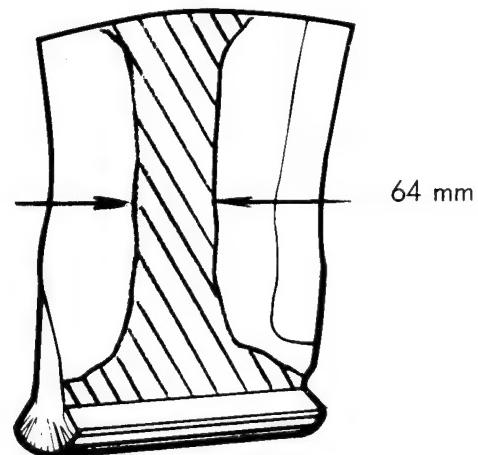
FIG. 32 S/N T-20

The sonic inspection of S/N T-20 revealed a large indication about 6.4 cm (2-1/2 inches) wide up the center for the full length of the blade. A section taken from the tip (within the area later machined off) was examined microscopically but did not yield any useful information about the cause of this indication. The indication looked suspiciously like the shape of one of the center plies, and it was hypothesized that a piece of Mylar separator may have been left in the blade during layup. The literature indicated that Mylar melts at 260°C and the blade was molded at 316°C so it seems unlikely that the presence of a sheet of the 0.05 mm (two mil Mylar) could easily be identified intact in the blade. More likely would be a slightly resin rich appearing area or a porous area in the shape of the Mylar ply separator. A small test laminate was fabricated with a strip of Mylar in the center and examined sonically and microscopically. The Mylar could not be identified sonically, and the photomicrograph did not show any clear indication of the separator film.

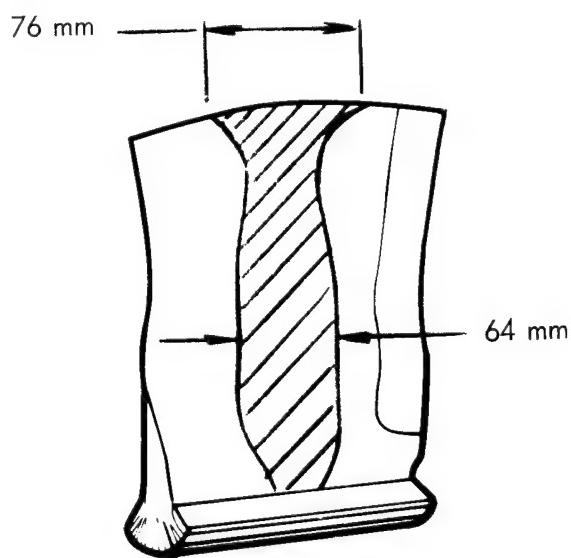
FIG. 35 S/N T-23H

The two hybrid blades, S/N's T-23H and T-24H, both showed sonic indications up the center. It is felt that both conditions were due to inadequate material in this portion of the blade. While table XIV indicates that the prepreg areal density figures were within acceptable limits, the inclusion of the glass fibers, with less available history on density and length/unit length data, made the calculated values less reliable than those on straight graphite fiber prepreg. Additionally, a limited manufacturing run of only two parts did not permit the empirical modification of material charge weights possible. As will be noted, the addition of three extra plies to the second blade did appreciably reduce the sonic indication area. There is no reason to believe that the use of hybrid prepreg should in any way reduce the attainable quality of the blades, and it is felt that further modification of prepreg thickness or charge weight would yield blades with equivalent quality to the straight graphite fiber blades.

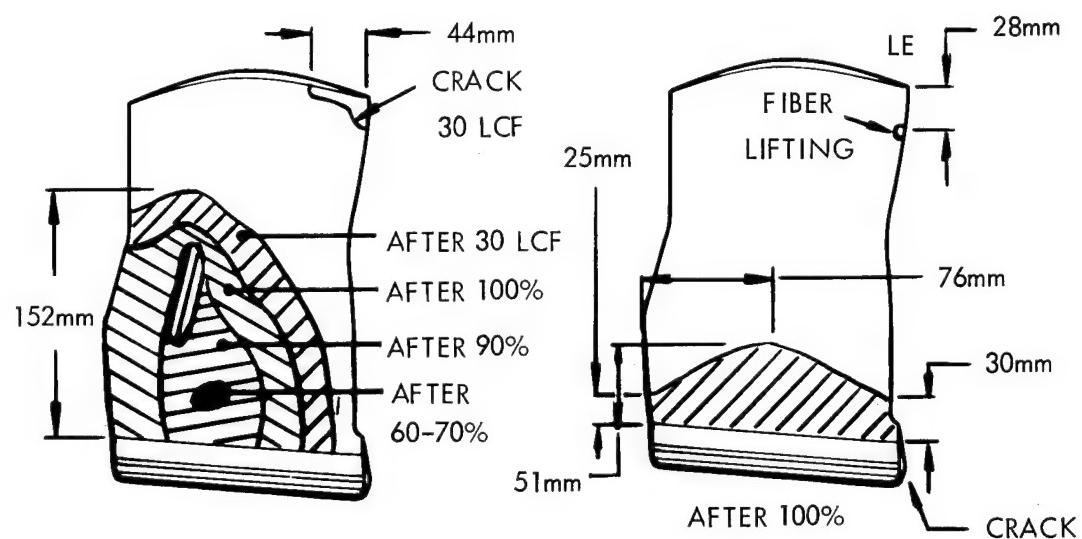
FIG. 40 S/N T-2

Blade S/N T-2 survived the entire testing procedure beginning with an as-fabricated indication (figure 39) which grew steadily through initial spin-up and 30 cycles of LCF (figure 40). No further change was noted through HFF and 10 additional cycles of LCF. The performance of S/N T-4 was similar to T-1 although the ultrasonic C-scan was clear initially. Likewise, S/N T-9 was clear initially but delaminated at 100% speed across the full chord width, above the root, as shown in figure 41.

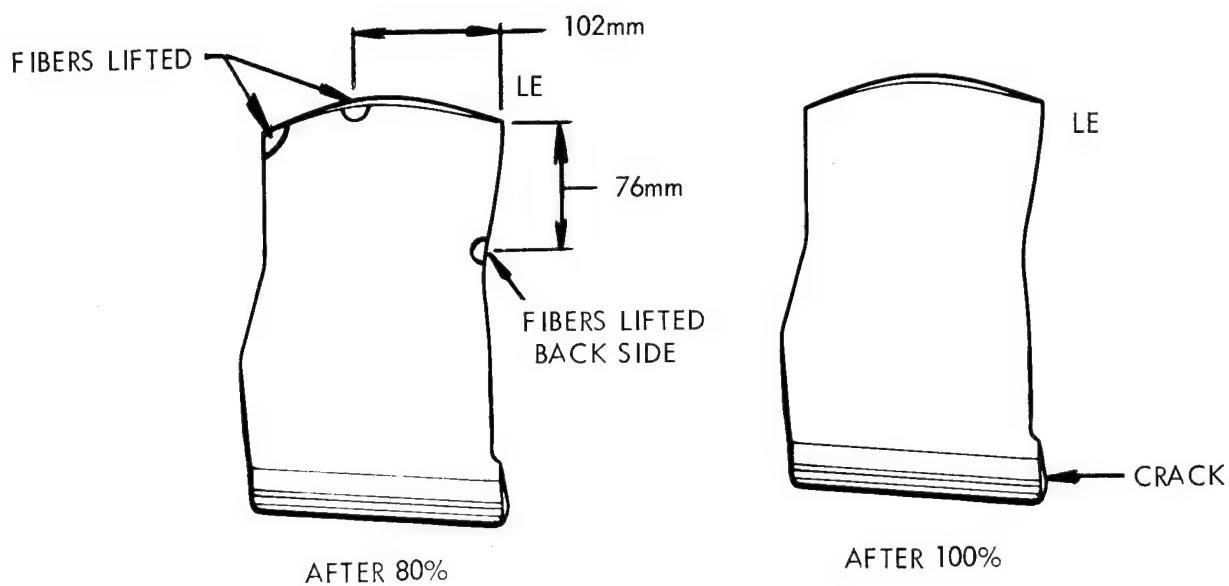
FIG. 42 S/N T-10

Blade S/N T-10, originally clear, survived the full test procedure and was ultrasonically clear through 100% speed. Local, minor fiber lifting was observed at the tip and mid-span on the leading edge after 80% speed (figure 42). At 100% speed a crack appeared in the root leading edge face in the composite between aluminum root wedges (figure 43). At 110% delamination occurred similar to the previous blade (figure 44). It was, however, further tested with no change noted in LCF and only slight expansion of the delaminated area observed after HFF (figure 45). No additional delamination occurred in the final LCF although some additional fiber lifting was noted (figure 46) and one pressure pad was lifted for a 5 cm length. A view of the low pressure face is illustrated in figure 46 along with the high pressure side of the airfoil showing all indications. The survival of this blade was surprising since it was deviated in machining; the root leading edge face was machined 2 mm (0.080 inch) short, placing the blade in the spin arbor significantly displaced from the true stacking axis.

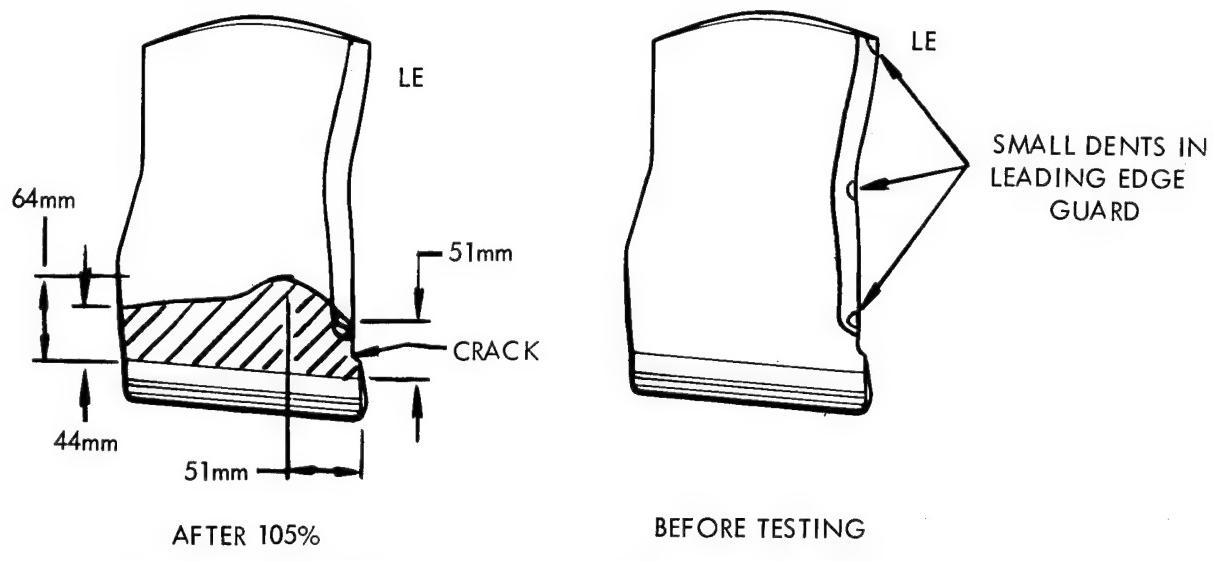
FIG. 48 S/N T-14

Blade S/N T-14 went through the entire testing procedure. Figure 48 illustrates an ultrasonic clear blade but some minor imperfections were observed on the leading edge sheath prior to test. Otherwise, the blade was sound except that the tip end was machined 2 mm (0.080 inch) short. Figures 49, 50 and 51 illustrate visual indications occurring during initial spin-up although no ultrasonic indications were noted through 110% speed, a decided improvement over previous blades. However, after 50 cycles LCF at 105% speed, delamination was experienced (figure 52). An additional small piece (25 cm length) of the leading edge guard was lost in HFF at the tip on the low pressure face, but no additional damage was incurred in the final 10 cycles in LCF.
